Mechanical & Thermal sub-team

Miniature Student satellite

M651

PREPARATION FOR SATELLITE INTEGRATION

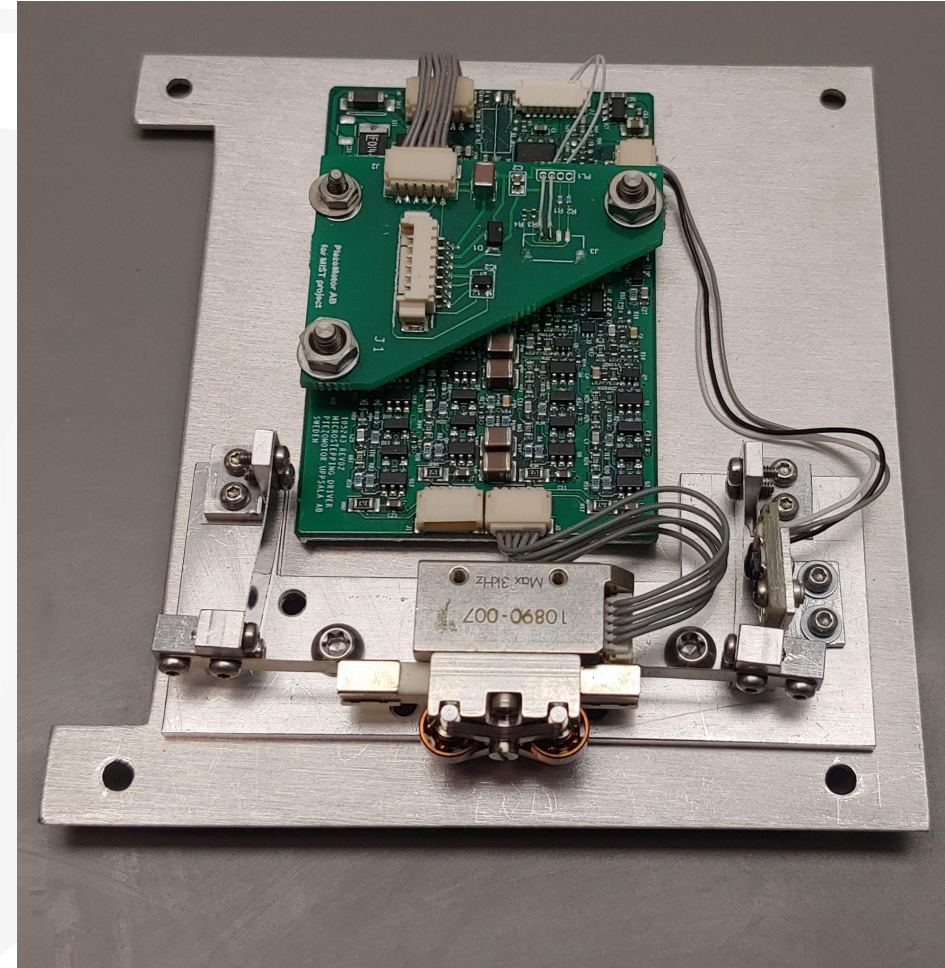
PiezoLEGS:

- 20+ hardware-related problems found
 - Too short screws
 - Too short threads
 - Missing Loctite
 - Loose screws

- 5 screws replaced
- Applied Loctite and tightened 28/30 screws
- Testing

- Motor still working, but sensor needs re-calibration

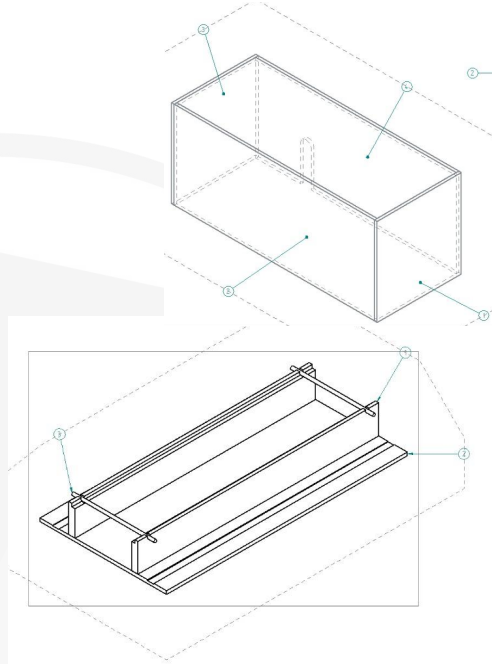
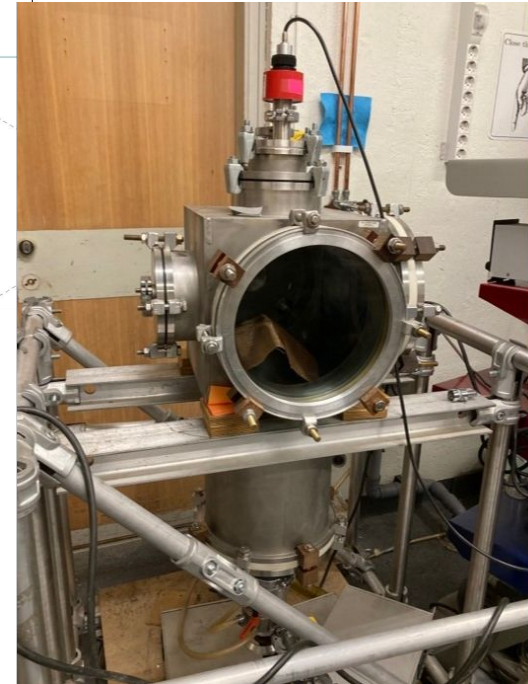
- Designed leak test equipment 3D models, 2D drawings and part lists

Item Number	Title	Material	Quantity
1	Side plate	Aluminium	2
2	Base plate	Aluminium	2

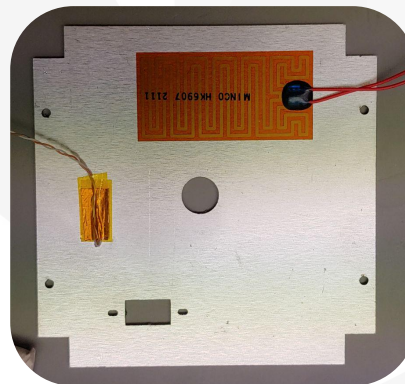
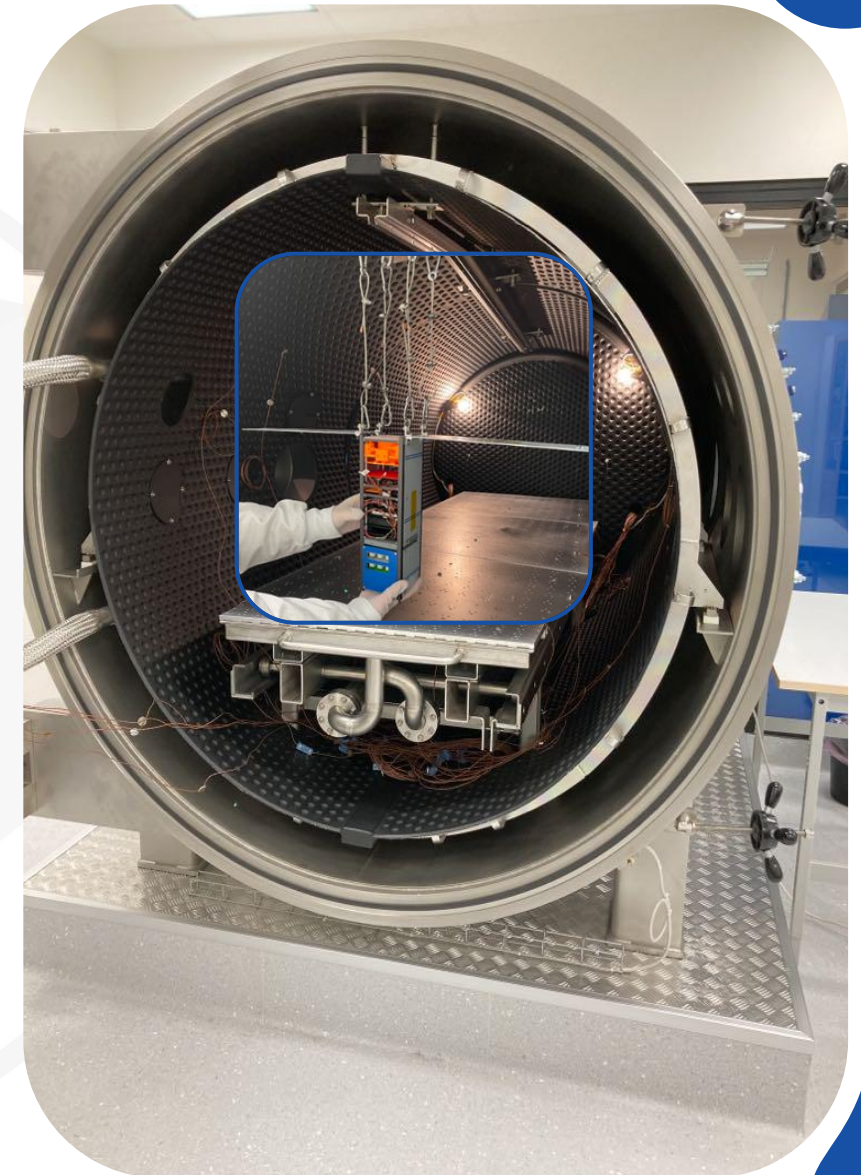
TBT: Thermal Balance Test

- Apply thermal gradients
- Measure temperature difference over interfaces

TVCT: Thermal Vacuum Cycling Test

- Equipment verification at thermal extremes

- Test procedure document
- Test systems correct functionality definition
 - Temperature readout
 - Power state
- Thermal simulation corrections
 - Heater placements
 - Power dissipation
- Heater loosening safety precaution
