MIST

Mechanical & Thermal sub-team

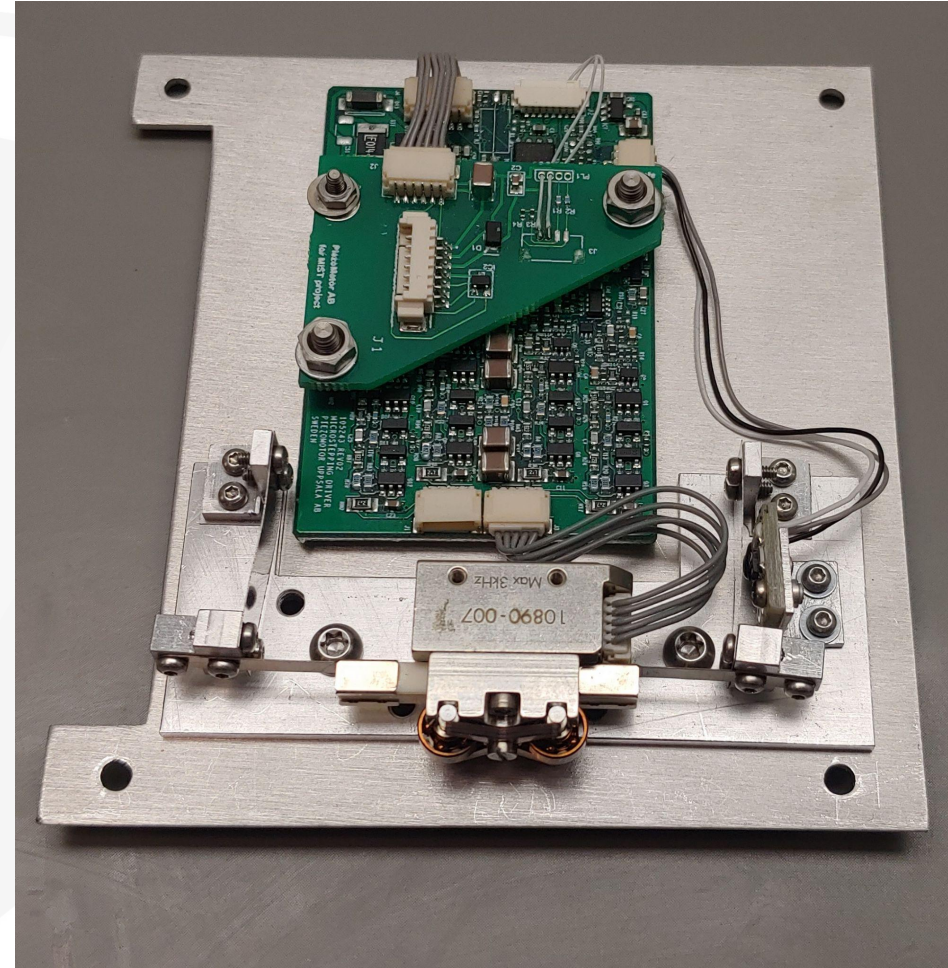
- New holes for mounting the motor board
- Applied Loctite and tightened 30/30 screws
- Re-calibration of optical sensor

- Add some Epoxy

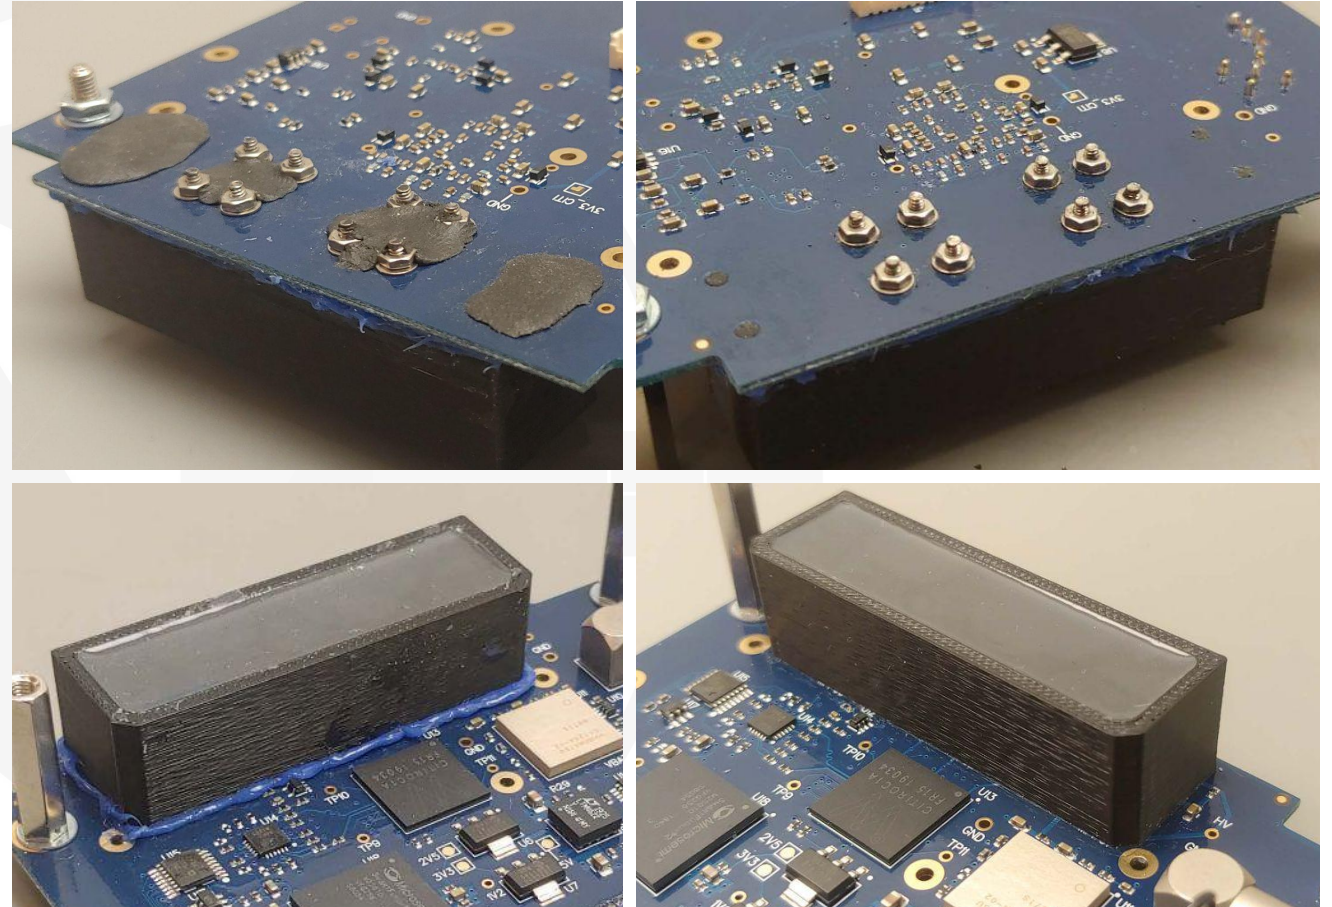
Problem:

- PiezoLEGS and CUBES cannot be mounted as close together as originally planned

Cause:

- Final design of PiezoLEGS and CUBES different from CAD-drawings - both are larger!

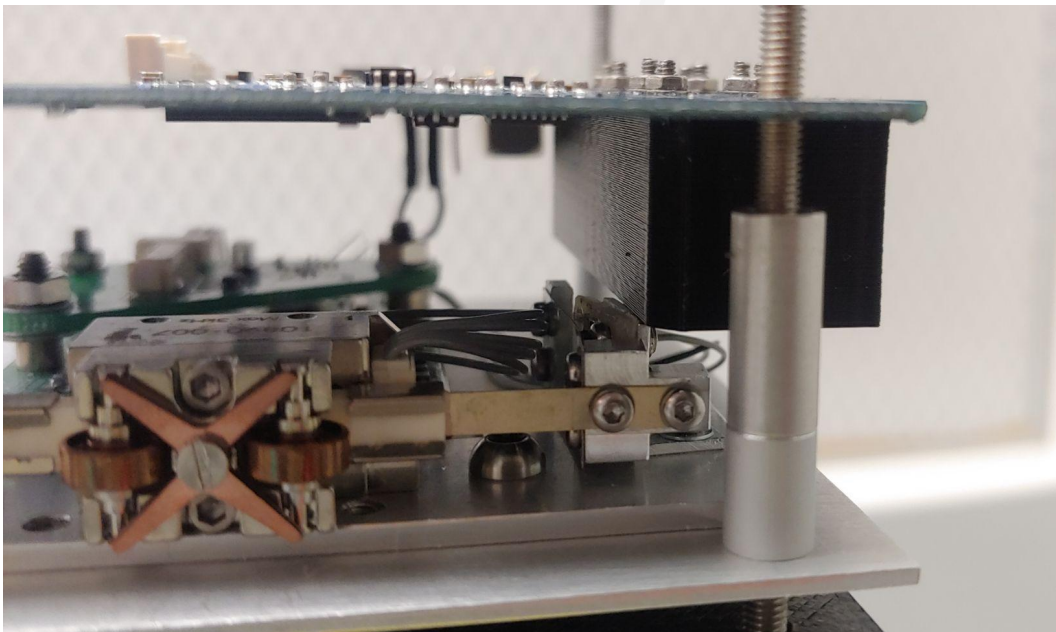
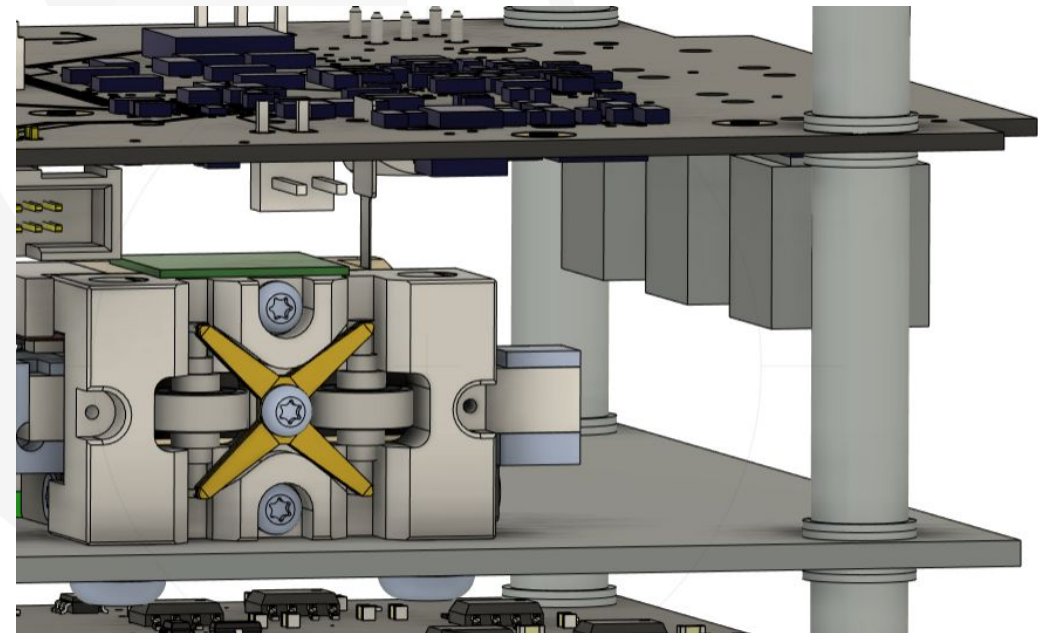
Solutions:

- a) Adjust distances between experiments:
 - CUBES-2 - LEGS: **+7 mm**
 - CUBES-1 - CUBES-2: **-3 mm**
 - SiC - SEUD: **-4 mm**
- b) Manufacture new aluminium mounting board for LEGS

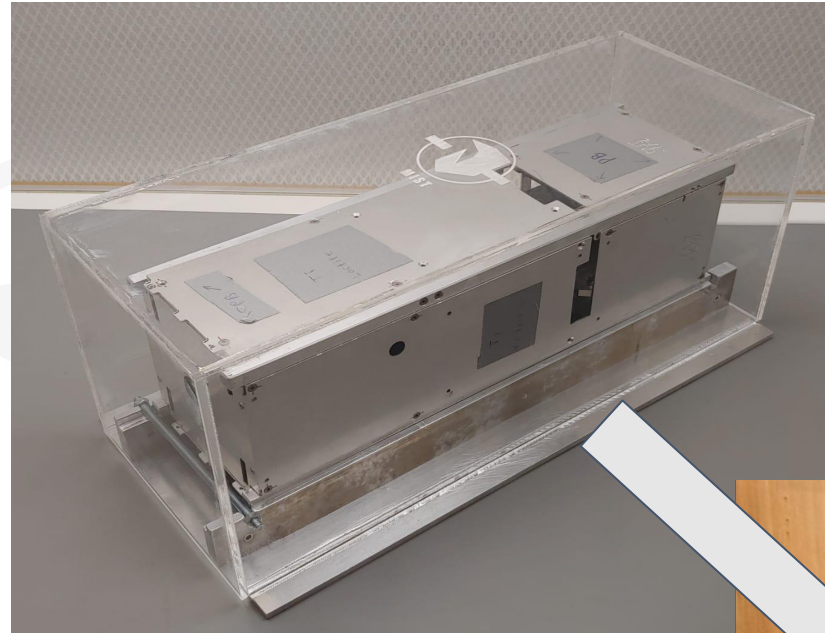
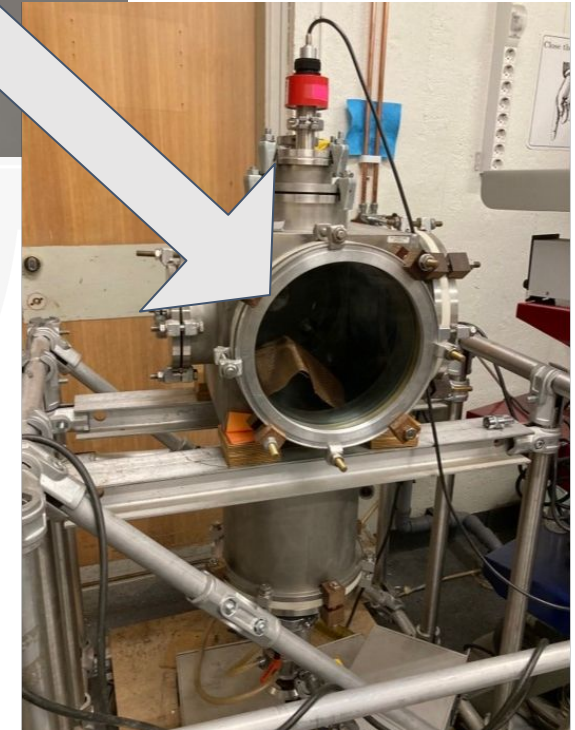
Purpose:

- To hold satellite
 - during transportation and
 - inside vacuum tank throughout leak test

Structure:

- 2 side parts
- 1 base part
- 1 threaded rod
- 2 nuts
- 6 screws

Machining processes:

- Milling, Drilling, Tapping

- Created a vacuum tank 3D model
- Manufactured leak test equipment
 - Aluminum satellite holder by manual mill
 - Acrylic satellite cover by laser cut
